### Post-fire investigations of prestressed concrete structures

**Fifth International Workshop on  
Performance, Protection & Strengthening of Structures  
under Extreme Loading  
June 28-30, 2015**

Title: Post-Fire Investigations of Prestressed Concrete Structures

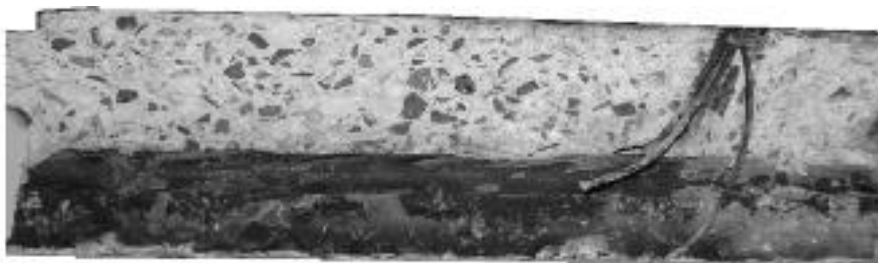
Side view

Concrete slab after testing in fire: Note the black substance is melted polypropylene used to protect the steel embedded in the slab. The protruding wires are glass fibre temperature gauges (thermocouples)

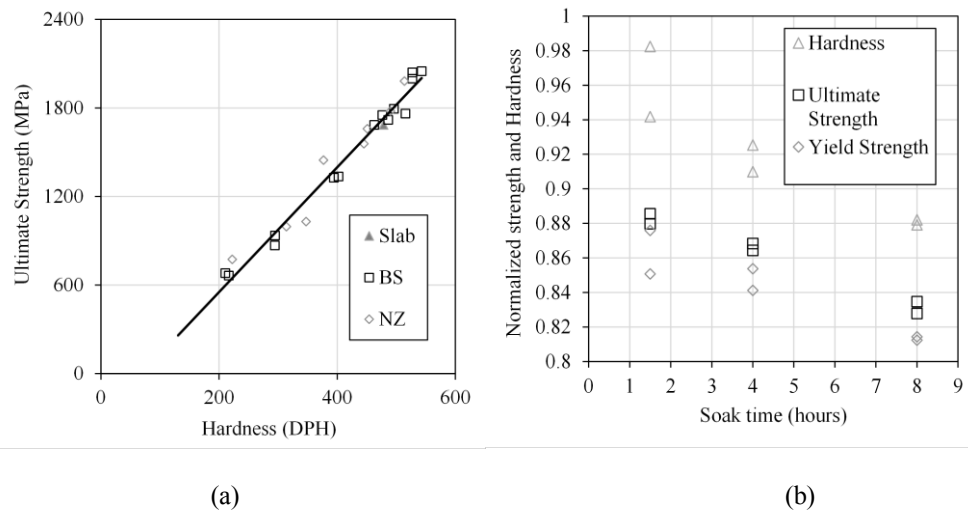
Investigation [6] indicated that the hardness provides an estimate of the residual strength with an accuracy of  $\pm 10\%$ . For exposure temperatures of 600C and over, the ability of hardness to be used as an indicator for the yield strength of the prestressing steel is more tenuous due to material properties. However, with regards to ultimate strength, derivation via hardness values maintains its accuracy. Although reference [6] considered prestressing steel from one mill, further research in this test program indicated that the behavior of other prestressing steels from different mills in general was similar. Therefore the same hardness-strength correlation could be used.

Figure 1. (a) Variation of Hardness with Ultimate Strength (b) Variation of Hardness with Soak time at 400C

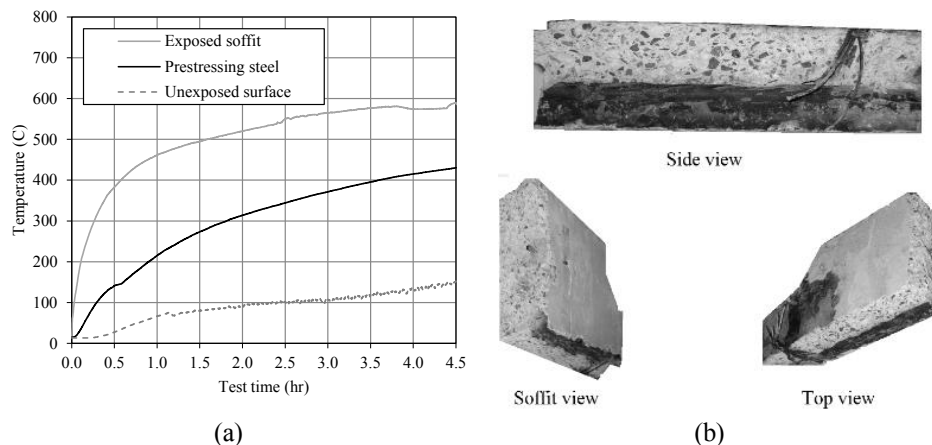
Figure 2. (a) Measured temperatures for slab test [4] (b) Excavated slab [4]

The slab was subjected to localized heating under the mid-span until the prestressing steel temperature reached critical at 426C. The slab was then allowed to cool. Of importance for discussion is that this slab was unbonded. That means the tendon was installed in a sheathed and greased configuration. The aforementioned bridge studies relied on a pre-cast bond between the tendon and the slab. The structural consequences of the slab tests are therefore not applicable for comparison with the previous discussion; however the indicators such as concrete color and temperature exposure of the prestressing steel (measured by two thermocouples) are applicable to instill confidence in the hardness test calibration procedure.

When exposed to fires, concrete will spall, crack and change color depending on the temperature reached. The slabs tested exhibited small transverse cracks along the soffit on the side not exposed to heating. On the underside of the slabs, exposed to heating, longitudinal and transverse cracks were respectively located directly below the prestressing steel, at the center and on each side of the heated zone. The concrete color can be used as an additional indicator for post-fire investigation as concrete changes color depending on the temperatures reached. However, this only provides a very general estimation. The afore-mentioned laboratory tested slab, exhibited an area of pink concrete extending only 10 mm into the slab on the side exposed to heat. This typically occurs at temperatures above 300C and the prestressing steel was heated to critical. Figure 2b illustrates a portion of the slab. Of interest is the black concrete. This was caused by the sheathing melting during the test and seeping out of the concrete.
